COMBINATION OF TERRESTRIAL LASERSCANNING, UAV AND CLOSE-RANGE PHOTOGRAMMETRY FOR 3D RECONSTRUCTION OF COMPLEX CHURCHES IN GEORGIA

T. Luhmann^{1*}, M. Chizhova², D. Gorkovchuk³, H. Hastedt¹, N. Chachava⁴, N. Lekveishvili⁴

KEY WORDS: Laserscanning, Photogrammetry, Data fusion, 3D reconstruction, Cultural heritage

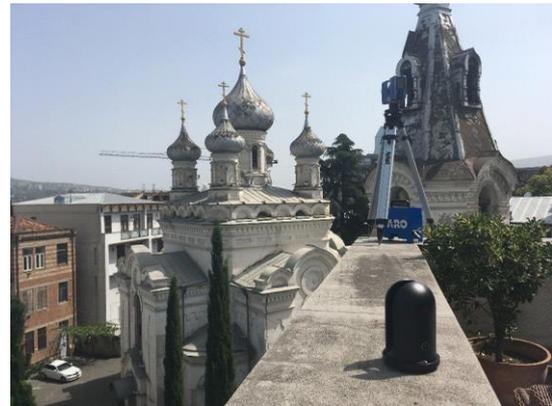
Figure 2. Russian-orthodox church in Lurdji complex; in foreground: Leica BLK360; in background: Faro scanner

The Faro Focus 3D X330 (Figure 2 in the background) is a geodetic laser scanner with phase-based distance measurement and a 3D point accuracy of approx. 2 mm at 10 m distance. The maximum range is 330 m. For laser scanning, a point distance of 6 mm at a distance of 10 m was selected. In this mode, a complete scan takes approx. 25 minutes, including the acquisition of image data. An overview of the captured data can be found in Table 1.

The Leica BLK360 laser scanner (Figure 2 in the foreground), which has been available on the market since 2017, is particularly easy to use. The device is primarily designed for simple building surveys with medium accuracy requirements at a range of up to 60 m. Initial studies on performance (Blaskow et al., 2018) confirm the 3D point accuracy of approx. 6 mm at a distance of 10 m as specified by the manufacturer. The distance measurement is carried out according to the WFD principle (wave form digitizer). Laser scanning with the BLK was carried out in High Density mode, which corresponds to a point distance of 6 mm at 10 m distance. In this mode, a complete scan, including the acquisition of panorama images, takes approx. 5 minutes. An overview of the acquired data can be found in Table 1.

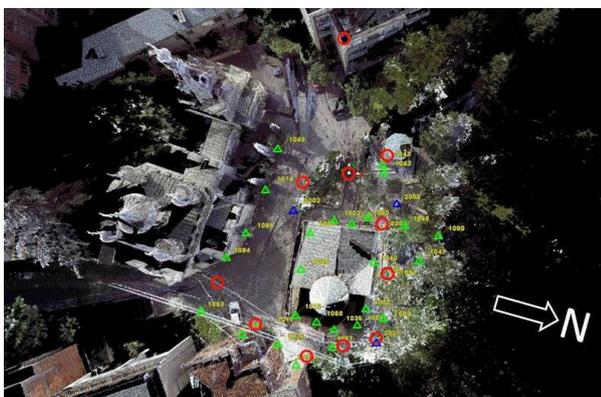
Figure 4. Overview of the registered Faro total point cloud with distribution of positions (red) and target marks (paper marks green, profit targets blue)

All recorded objects were marked with targets which were placed at a distance of approx. 5-10 m from each other on the building and in the rear surroundings (overview in Figure 4). As mentioned before, the targets could not be measured by

mean point resolution is between 3 mm in areas close to the ground and 5 mm on the tower. Figure 4 shows an overview of the registered point cloud with the positions and the recorded targets.

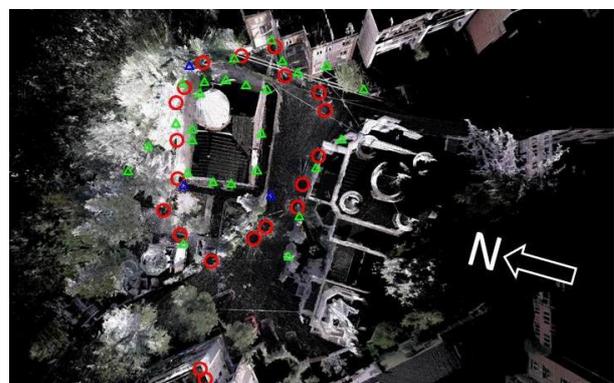
Figure 5. Overview of the registered BLK total point cloud with distribution of positions (red) and target marks (paper marks green, profit targets blue)

Also for the BLK scans a first registration with the program ReCap was carried out on site. The later total registration with Register 360 resulted in an average standard deviation of 9 mm. The registration was carried out using the targets with subsequent optimization (ICP). The mean point resolution lies between 4 mm in areas close to the ground and 8 mm at the tower. When registering with the Cyclone software, the precision of the registration improves to 4 mm. Figure 5 shows an overview of the registered point cloud with the positions and the recorded targets.

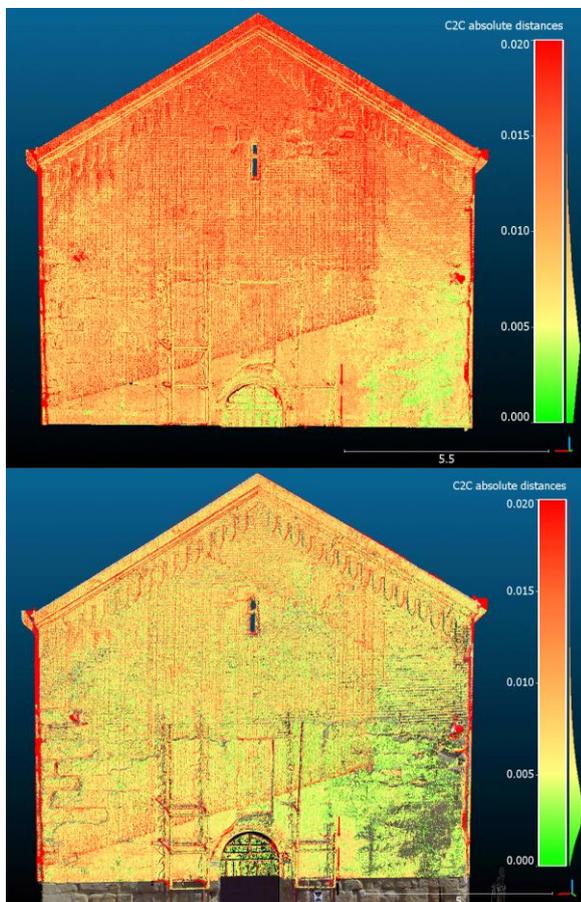
Figure 6. Comparison Faro-BLK: left Cloud-to-Cloud; right Cloud-to-Cloud after ICP (in mm)

2.4.2 Quality of point clouds: The quality of the point clouds is analysed in this article only exemplarily. The deviations of the BLK scan from the Faro point cloud are examined as a reference. A first comparison of the two registered and unfiltered point clouds on an outer wall by cloud-to-cloud comparison (function Cloud/Cloud-Distance in CloudCompare, see Figure 6 top) shows that both point clouds fit together in the range of 5-10mm, with the exception of the areas of the object edges (building corners, roof ridge). Straight-line jumps in the deviations are conspicuous, which are presumably due to systematic residual deviations of the registrations or the inclusion of scans from neighbouring buildings. Furthermore, a growing discrepancy with increasing building height is clearly discernible. Their cause probably lies in the exclusively horizontal distribution of the target marks as well as possibly a worse scan accuracy with increasing vertical angle.

Figure 6 bottom shows the result after an additional adjustment of the scans via ICP. This largely eliminates the height-dependent systematics, which again indicates a datum problem during registration. The histogram of the deviations shows a maximum at 4mm, which indicates a total systematic shift of the point clouds to each other.

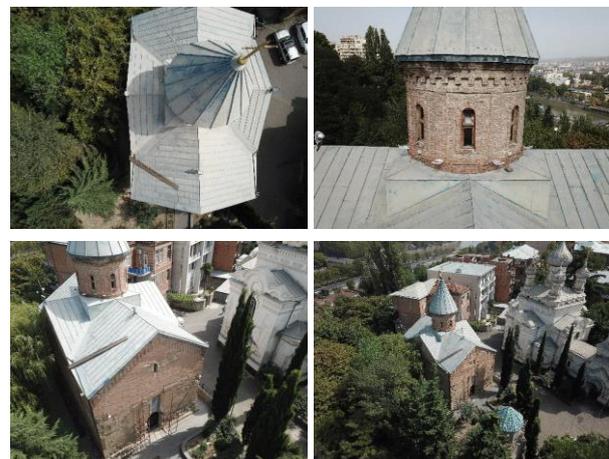
Figure 7. Example images of UAV flights

The local partners provided a DJI Mavic Pro drone with FC 220 camera (12 Mpixel) (focal length $f=4.7\text{mm}$, image format $6.4\text{mm} \times 4.8\text{mm}$, pixel size $1.6\mu\text{m}$). The maximum flight duration is approx. 22 minutes. The drone was manually controlled by an experienced pilot. A meandering image configuration with vertical images as well as two circular flights with oblique images from different distances were captured. Table 2 compiles the most important flight data. Figure 7 shows example images of the three different flights.

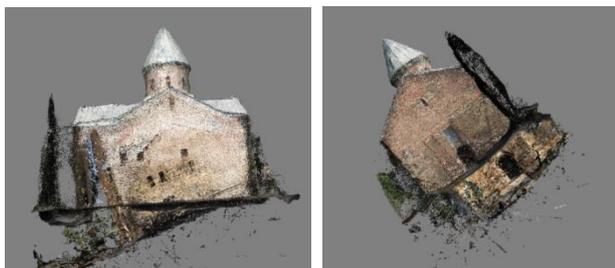
Figure 8. Views of a reduced dense point cloud after faulty automatic orientation in PhotoScan 1.4.1; left: faulty orientation with double reconstruction and rotation; right: front view of the church with double reconstruction of the entrance portal

The automatic processing of all image data from the different data sets, which are subject to very different acquisition conditions and qualities for evaluation in PhotoScan, proved to be difficult. The automated alignment of all images referred to a clear orientation error, which was shown by the formation of two reconstructions of the church rotated towards each other. Figure 8 shows views of a reduced dense point cloud after the automatic orientation of all images. In addition to the double reconstruction of the same building, it can be seen here that these are strongly rotated (Figure 8 left) and that there is also a difference in scale (Figure 8 right). It could be identified that the images of the DJI and the Canon EOS 200D result in an equivalent reconstruction, while the images of the Canon EOS 6D lead to a clear misorientation. For this reason, in PhotoScan only a reduced image data set was used for the evaluation.

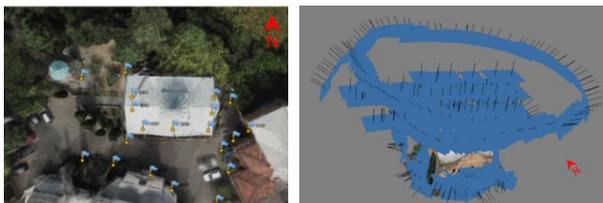
Figure 9. left: Control point overview of the evaluation in PhotoScan; right: Overview of the image data from image flight and terrestrial images after the image orientation in PhotoScan

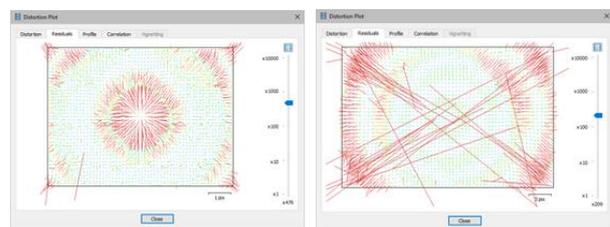
Figure 10. Image residuals after bundle adjustment in PhotoScan; left: DJI FC 220; right: Canon 200D

The combined blocks were then jointly adjusted taking into account the simultaneous calibration of the cameras involved (f, cx, cy, k1-k3, p1-p2, b1-b2). The average reprojection error (RMS_{back}) is 0.9 pixels for all tie points and 0.4 pixels for the control points. The mean 3D deviation at the control points is 8mm with an a priori accuracy of 7mm (see Table 3). The achieved deviations appear realistic. Nevertheless, the distributions of the image residuals in PhotoScan (Figure 10) for both cameras show a clear systematic, which either indicate deficiencies in the modelling of the interior orientation or are due to the implementation. RealityCapture does not provide any output of image residuals.

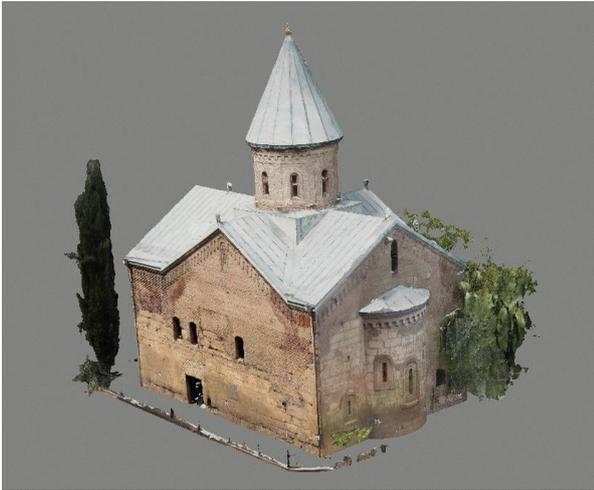
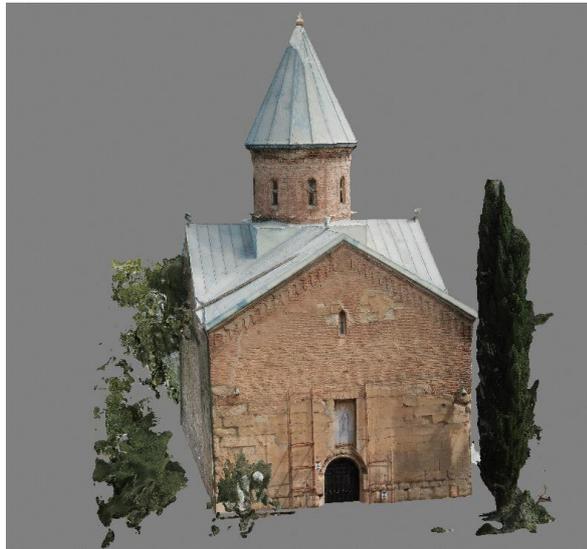
Figure 11. Textured and meshed 3D model from PhotoScan (Alignment "medium", Dense cloud "high", Mesh "arbitrary, high", Texture "adaptive orthophoto, mosaic")

The textured and meshed 3D model from Figure 11 is based on the generation of a dense point cloud in the quality level "high" (reduced by factor 2 to the original resolution, 42 million points). The subsequent 3D meshing was carried out with the highest mesh density (resulting in approximately 8.4 million areas). For texturing, the "adaptive orthophoto" method was chosen, which selects the image on the basis of the surface alignment and at the same time allows mosaicing.

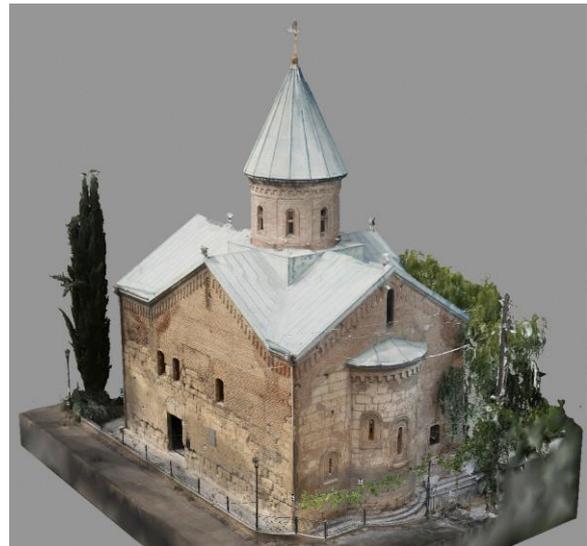
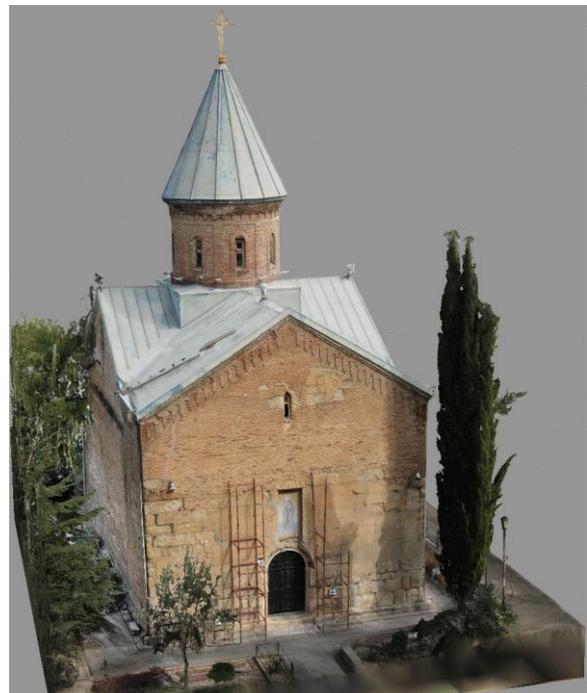
Figure 12. Meshed complete model with RealityCapture 1.0.3

Figure 12 shows the calculated 3D model as meshing (approx. 5mm point spacing). The high quality is proven on the one hand by the completeness of the overall model, but on the other hand detailed views also show how well the object was reconstructed, especially on the sides that are difficult to access (Figure 13). Finest details such as the scaffolding at the entrance or filigree cast-iron fences in the rear area are modelled correctly. Only the cross on the top of the tower still shows "shadows", which might be caused by the background problem mentioned above as well as some missing pictures.

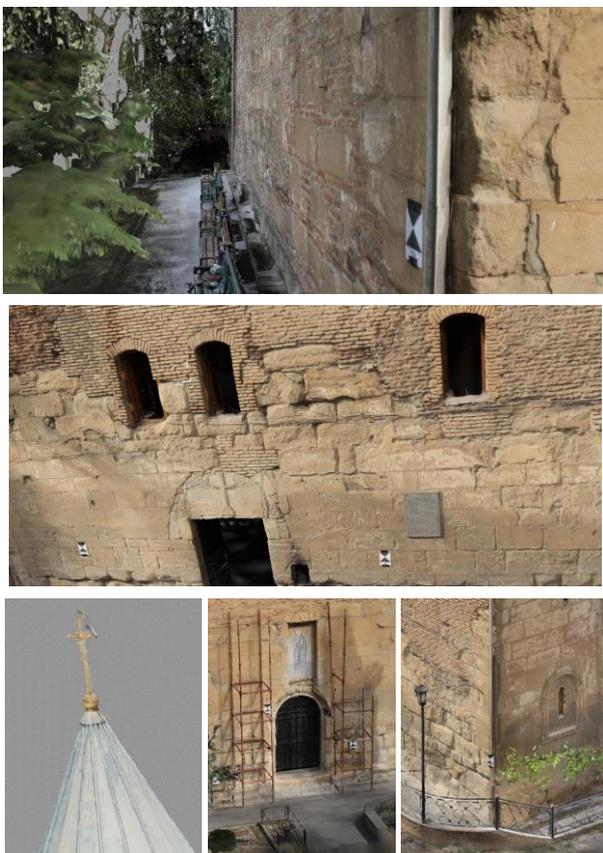
Figure 13. Detailed views from the point cloud calculated with RealityCapture

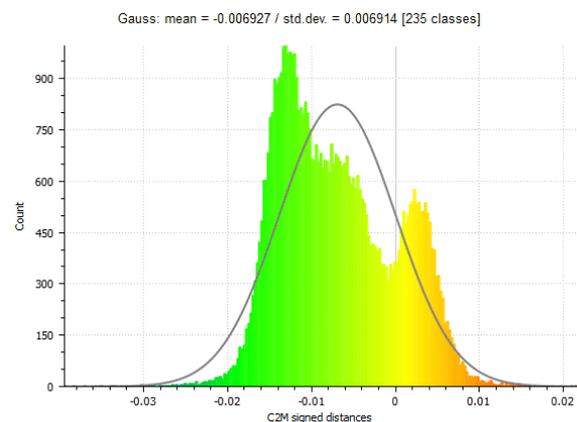
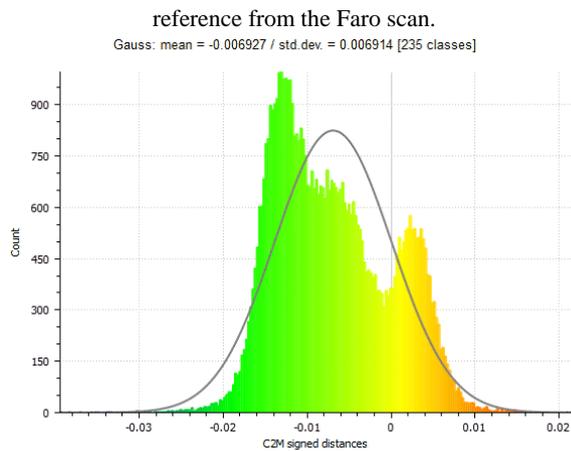
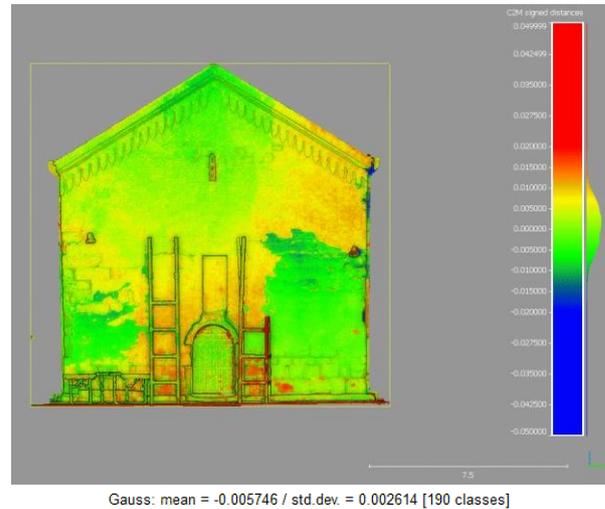
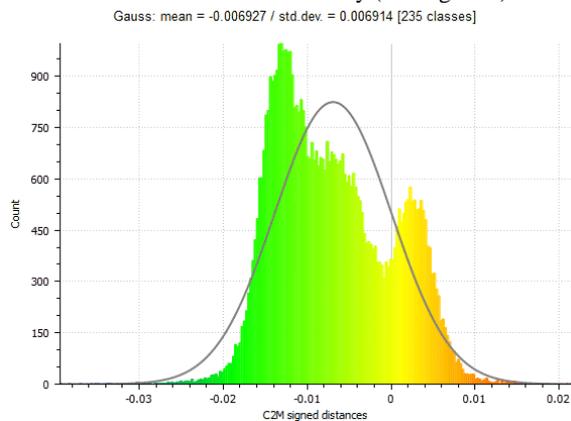
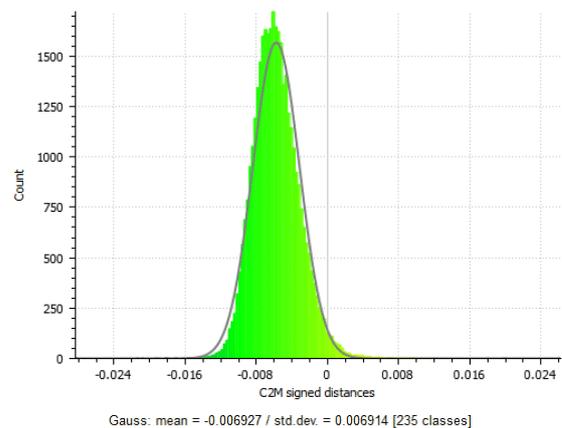
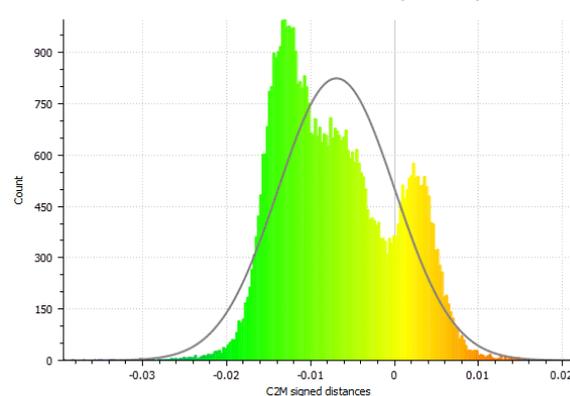
Figure 14 shows a first comparison (cloud-to-mesh) of the point cloud calculated with RealityCapture with all image data and simultaneous use of the BLK360 point cloud, compared to the

Figure 14. Comparison of the point cloud calculated with RealityCapture (BLK360 and images) compared to Faro

Figure 14a,b show the deviations over the entire object facade. The average deviation is only 2 mm, i.e. the joint evaluation of the TLS and the image data leads again to a high-quality 3D model of the surface. Areas of similar deviations can be seen here, which can at least partly be explained by the very different surface texture of the masonry (see Figure 1).

Figure 14c and d show the corresponding histograms of the deviations in the lower and upper areas of the facade. Here it becomes visible that in the upper range worse data are available, analogous to the result from section 2.4.2.
