# COMBINATION OF TERRESTRIAL LASERSCANNING, UAV AND CLOSE-RANGE PHOTOGRAMMETRY FOR 3D RECONSTRUCTION OF COMPLEX CHURCHES IN GEORGIA

## Commission II, WG II/8

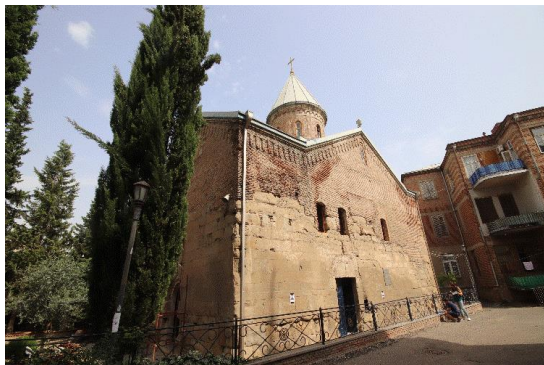
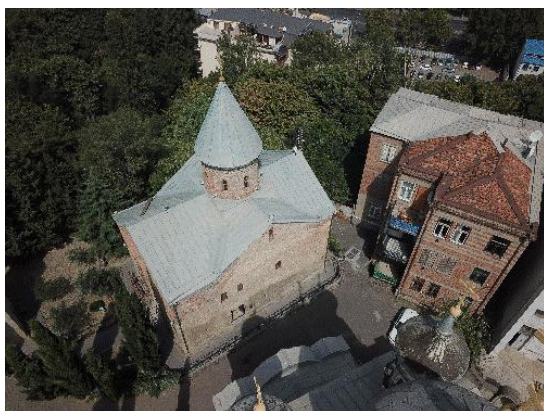
Figure 1. Andreas Church in Lurdji complex

**1.2.1 Lurdji Monastery:** The Lurdji Monastery is an orthodox architectural complex in Tbilisi (Figure 1). The monastery was founded in the 7th century, the oldest parts date back to the 12th century, which corresponds to the reign of Queen Tamar. In the 16th century the monastery was destroyed by Persians and restored only a century later. Currently, the sacral complex consists of two churches and the associated historical park Vera. After its destruction, the Andreas Church was restored in the 17th century as a basilica with a three-part nave. At the end of the 19th century, the church was reconstructed according to a project by A. Chizhov and received a new spherical dome, which was not typical for Georgian architecture. This dome was replaced in 1995 by a classic Georgian conical dome. The roof, once covered with blue ceramic tiles, is now made of blue-grey painted zinc sheets. The roof design determined the name of the monastery: "lurdji" means blue. Due to the various alterations, the church is not in the typical style of Georgian churches with a cruciform ground plan, but in a rectangular basic form with a cross-roof and a central tower, which has a cylindrical base and a conical top.

The church measures approximately 17 m x 12 m x 25 m (W x L x H). It is located in the middle of a built-up residential area and the park on the edge, so that access from the ground was sometimes very restricted. The material of the outer walls consists of sandstone or brick and has a natural roughness as well as broken out places, which resulted from weathering and wear. The roof surfaces are largely texturally poor.

For the object the measurement of the outer skin was determined. Two UAV flights, two terrestrial DSLR image sets and two laser scan measurements were conducted.

Figure 14a,b show the deviations over the entire object façade. The average deviation is only 2 mm, i.e. the joint evaluation of the TLS and the image data leads again to a high-quality 3D model of the surface. Areas of similar deviations can be seen here, which can at least partly be explained by the very different surface texture of the masonry (see Figure 1).

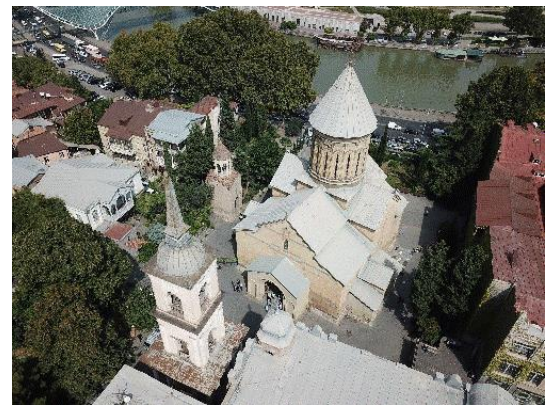
Figure 3. Sioni Cathedral

The Sioni Cathedral is the historical main church of the city of Tbilisi and one of the most important centres of Georgian orthodoxy (Figure 3). The construction of the original church began in the 6th century by the Georgian king Wachtang I. Gorgassali, its final construction dates back to the 7th century. This first church was completely destroyed after the establishment of the Tbilisi Emirate. The new Sioni Cathedral was built in the 12th century and underwent several destructions and reconstructions (17th and 18th centuries). After its restoration in 1980-1983, the church retained its medieval appearance and stylistically corresponds to the classical pre-Mongolian religious architecture of Georgia.

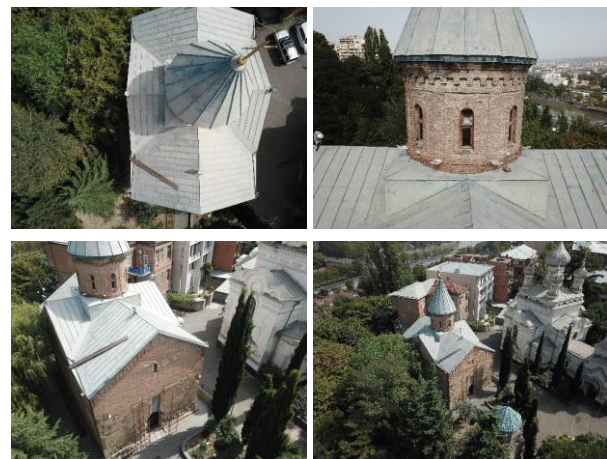
Figure 7. Example images of UAV flights

The local partners provided a DJI Mavic Pro drone with FC 220 camera (12 Mpixel) (focal length  $f=4.7\text{mm}$ , image format  $6.4\text{mm} \times 4.8\text{mm}$ , pixel size  $1.6\mu\text{m}$ ). The maximum flight duration is approx. 22 minutes. The drone was manually controlled by an experienced pilot. A meandering image configuration with vertical images as well as two circular flights with oblique images from different distances were captured. Table 2 compiles the most important flight data. Figure 7 shows example images of the three different flights.

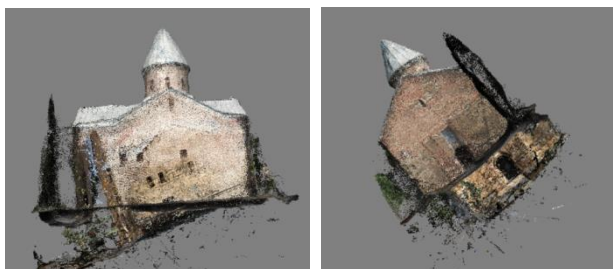
Figure 8. Views of a reduced dense point cloud after faulty automatic orientation in PhotoScan 1.4.1; left: faulty orientation with double reconstruction and rotation; right: front view of the church with double reconstruction of the entrance portal

The automatic processing of all image data from the different data sets, which are subject to very different acquisition conditions and qualities for evaluation in PhotoScan, proved to be difficult. The automated alignment of all images referred to a clear orientation error, which was shown by the formation of two reconstructions of the church rotated towards each other. Figure 8 shows views of a reduced dense point cloud after the automatic orientation of all images. In addition to the double reconstruction of the same building, it can be seen here that these are strongly rotated (Figure 8 left) and that there is also a difference in scale (Figure 8 right). It could be identified that the images of the DJI and the Canon EOS 200D result in an equivalent reconstruction, while the images of the Canon EOS 6D lead to a clear misorientation. For this reason, in PhotoScan only a reduced image data set was used for the evaluation.

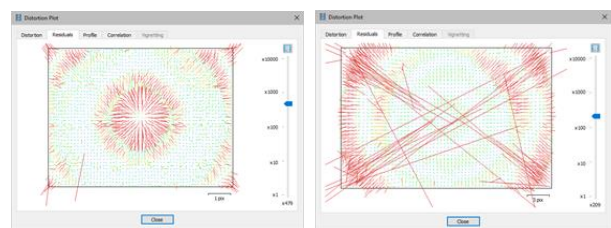
Figure 10. Image residuals after bundle adjustment in PhotoScan; left: DJI FC 220; right: Canon 200D

The combined blocks were then jointly adjusted taking into account the simultaneous calibration of the cameras involved ( $f$ ,  $c_x$ ,  $c_y$ ,  $k_1$ - $k_3$ ,  $p_1$ - $p_2$ ,  $b_1$ - $b_2$ ). The average reprojection error (RMS<sub>back</sub>) is 0.9 pixels for all tie points and 0.4 pixels for the control points. The mean 3D deviation at the control points is 8mm with an a priori accuracy of 7mm (see Table 3). The achieved deviations appear realistic. Nevertheless, the distributions of the image residuals in PhotoScan (Figure 10) for both cameras show a clear systematic, which either indicate deficiencies in the modelling of the interior orientation or are due to the implementation. RealityCapture does not provide any output of image residuals.

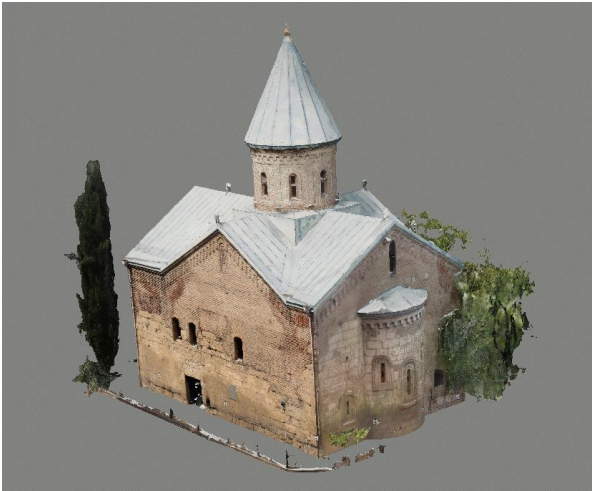
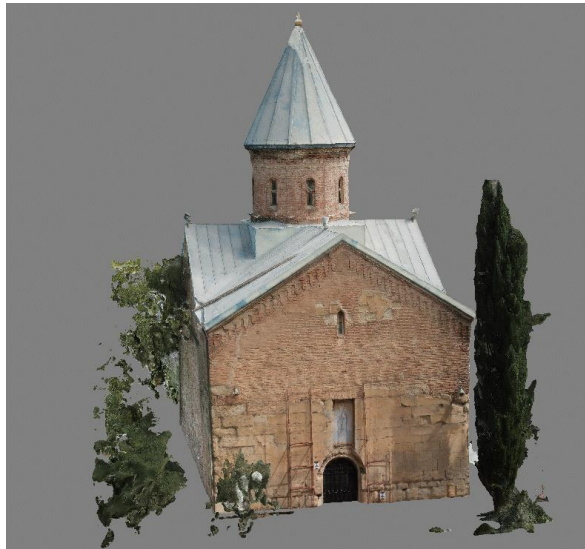
Figure 11. Textured and meshed 3D model from PhotoScan (Alignment "medium", Dense cloud "high", Mesh "arbitrary, high", Texture "adaptive orthophoto, mosaic")

The textured and meshed 3D model from Figure 11 is based on the generation of a dense point cloud in the quality level "high" (reduced by factor 2 to the original resolution, 42 million points). The subsequent 3D meshing was carried out with the highest mesh density (resulting in approximately 8.4 million areas). For texturing, the "adaptive orthophoto" method was chosen, which selects the image on the basis of the surface alignment and at the same time allows mosaicing.

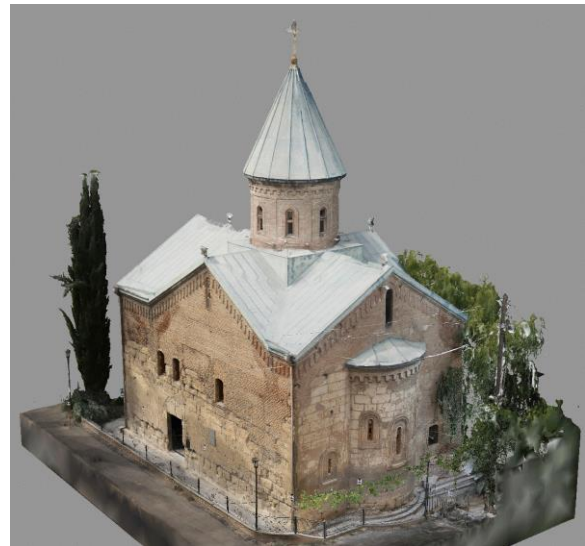
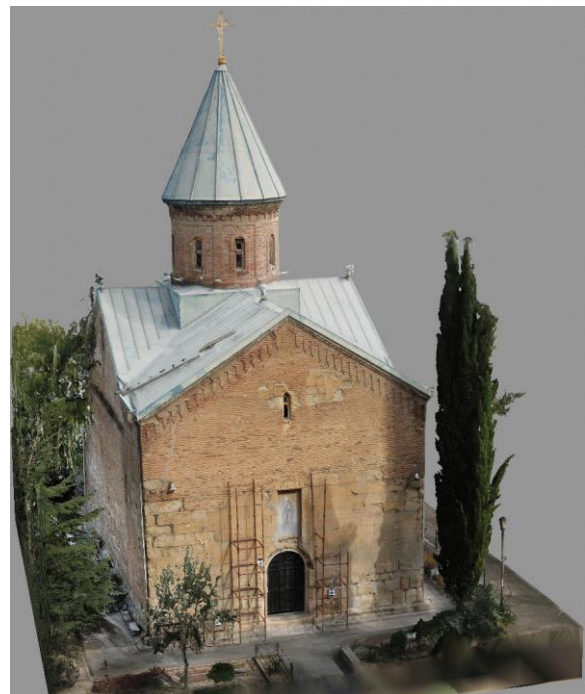
Figure 12. Meshed complete model with RealityCapture 1.0.3

Figure 12 shows the calculated 3D model as meshing (approx. 5mm point spacing). The high quality is proven on the one hand by the completeness of the overall model, but on the other hand detailed views also show how well the object was reconstructed, especially on the sides that are difficult to access (Figure 13). Finest details such as the scaffolding at the entrance or filigree cast-iron fences in the rear area are modelled correctly. Only the cross on the top of the tower still shows "shadows", which might be caused by the background problem mentioned above as well as some missing pictures.

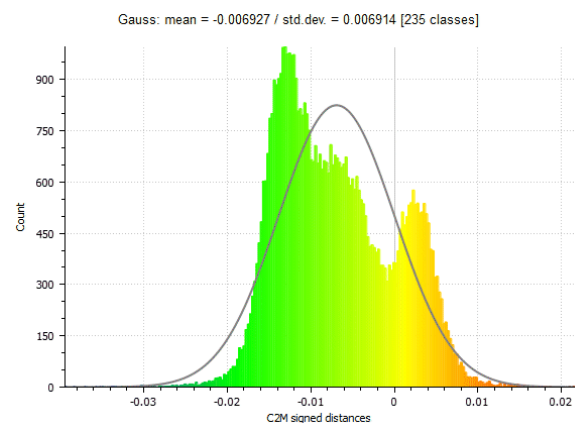
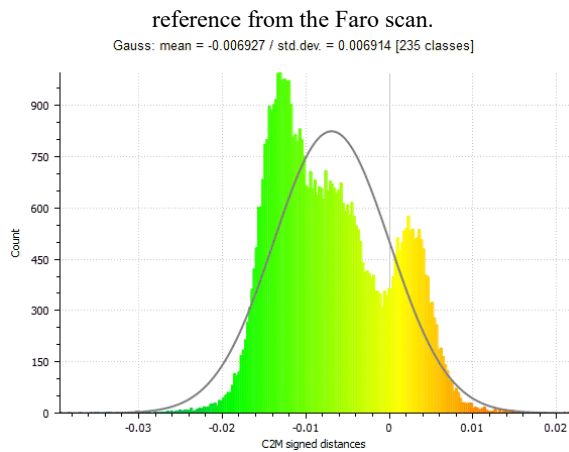
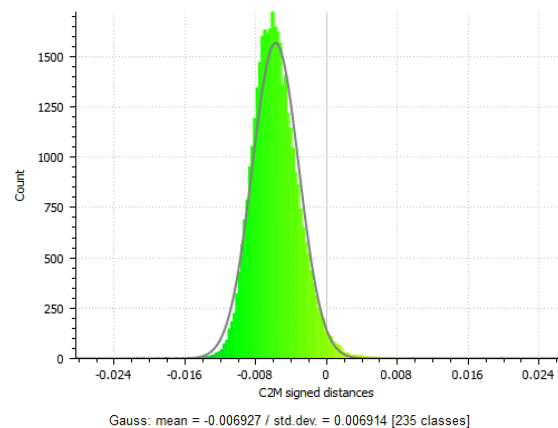
Figure 14. Comparison of the point cloud calculated with RealityCapture (BLK360 and images) compared to Faro

Figure 14 shows a first comparison (cloud-to-mesh) of the point cloud calculated with RealityCapture with all image data and simultaneous use of the BLK360 point cloud, compared to the

Figure 14c and d show the corresponding histograms of the deviations in the lower and upper areas of the façade. Here it becomes visible that in the upper range worse data are available, analogous to the result from section 2.4.2.
